The Local Oscillator

The Newsletter of Crawford Broadcasting Company Corporate Engineering

JULY 2010 • VOLUME 21 • ISSUE 7 • W.C. ALEXANDER, CPBE, AMD, DRB EDITOR

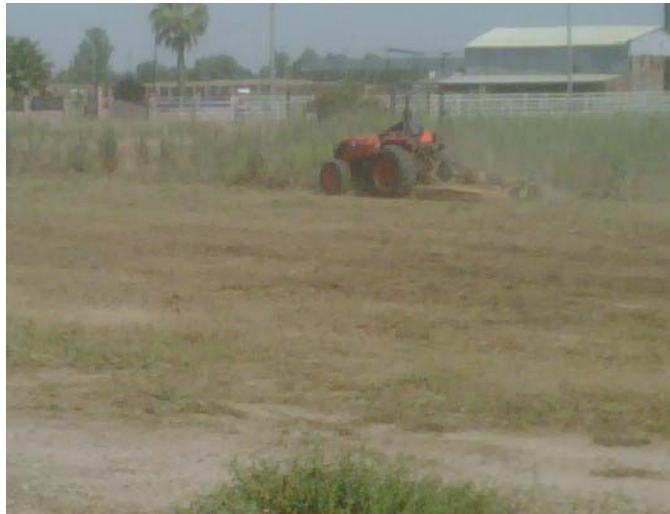
Mowing the KCBC site for the first time in many years

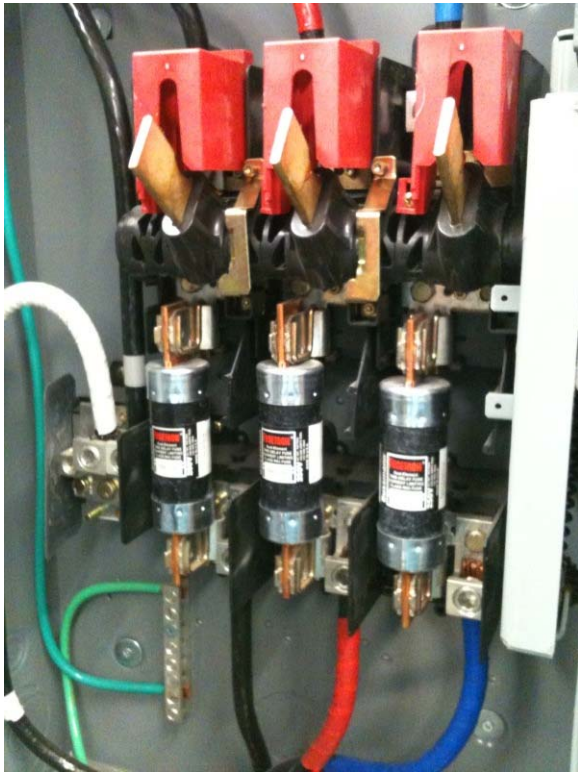
Transmitter service disconnect wired "upside down" – don't touch those fuses!

Fourth observation: we found out that there are a few terminals on those strips which are wired *on the supply side* of the control relay; the rest are on the load side. That pretty much pointed to the source of the problem. But as a part of the process, we also checked the voltage going all the way back to the wall disconnect. And that's where we discovered the wiring problem. When we saw it, we looked at each other with disbelief. With the disconnect shut off, we were able to take voltage readings on what we'd thought would be the cold (floating) side of the fuses. Ooops! (See the photo)

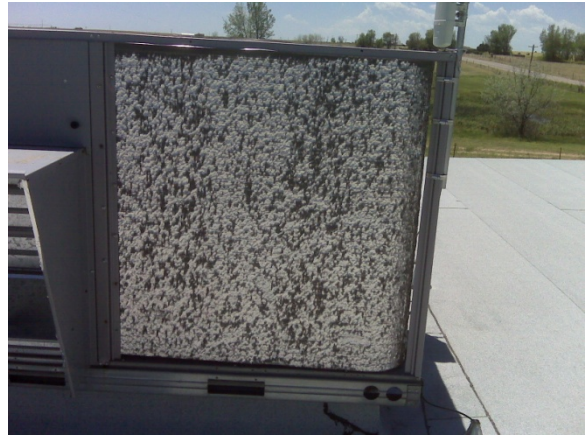
The KLTT backup A/C unit coil is all beat to "hail"

You see, that Saturday and Sunday, it was wet. I kept getting alarms telling me KLTT had been switched to low power (an external protective circuit does this at the first hint of lightning). It would then go back to high power after a few minutes of no further hits. This pattern repeated itself all day long. This told me that it was most likely windy out there since the weather didn’t look severe. I was partly wrong. While it was extremely windy, I believe a strong storm cell moved through. The wind blew the front cover off the main A/C unit and it landed in the antenna field behind the building, exposing the unit to the outside elements. Another thing Choice found was that the backup unit was dead. It had hailed tremendously and the condenser coil now looks like I took a hammer to it and just kept beating it.
